HWY-11-MH-012  
Truck Trailer - Amtrak Train Collision  
Miriam, NV  
June 24, 2011

**TRACTOR-TRAILER HIGHWAY/RAIL GRADE CROSSING COLLISION STRIKING  
AMTRAK PASSENGER TRAIN**

**Miriam, Nevada**

**SIGNAL GROUP FACTUAL REPORT**

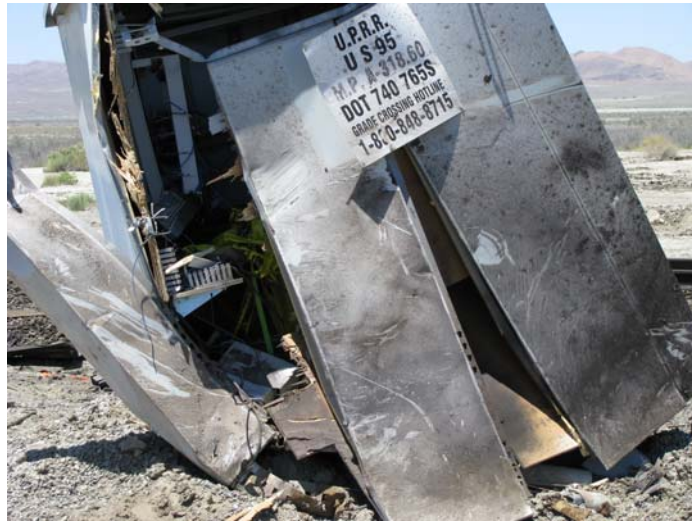
**Figure 1. Damaged Grade Crossing Signal System Bungalow.**

Representatives from the NTSB, UP and the Federal Railroad Administration (FRA) participated in the field inspection of the grade crossing signal system. The post accident inspection found the signal bungalow damaged beyond repair. All grade crossing signal system cases and junction boxes showed no indications of tampering or vandalism that would interfere with the operation of the grade crossing signal system. No exceptions were identified with the design of the grade crossing signal system. Extensive signal damage to the bungalow incurred as a result of the collision.

The UP engineering personnel estimated the total grade crossing signal system damages at approximately \$300,000.00. This figure included costs for the total replacement and installation of the demolished grade crossing signal system bungalow.

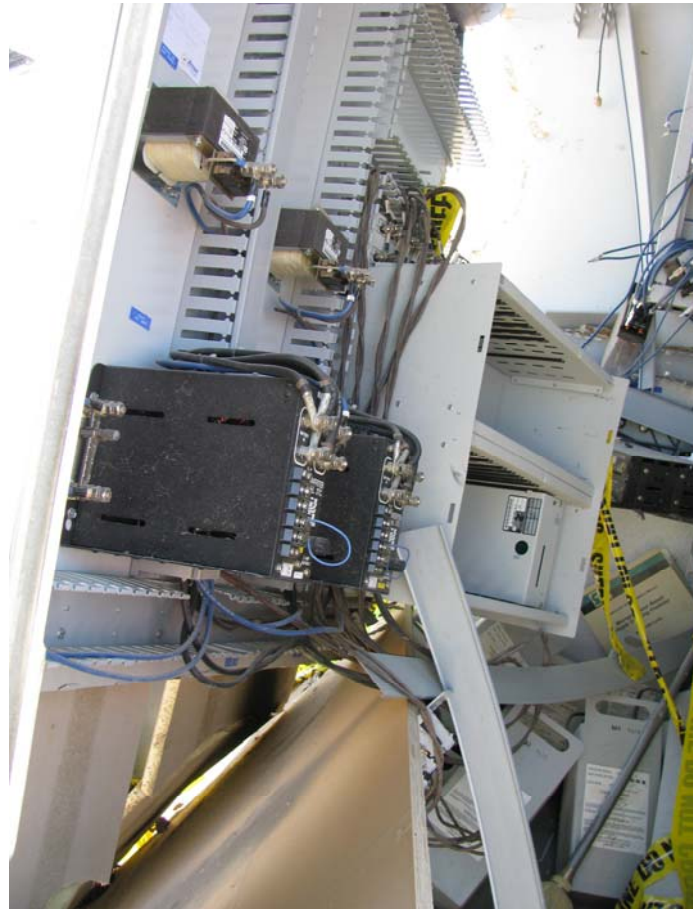
Due to the extensive damage to the recorder modules no usable data was retrieved.

**Figure 3. Damaged GCP-3000 unit.**
